LEVEL 2

Your survey and valuation report

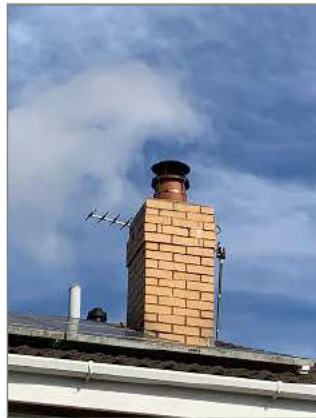
The chimney stacks appears straight and upright, with no leaning or structural defects observed.

The brickwork and pointing is generally in satisfactory condition.

The chimney pot appears secure and upright. I was unable to adequately assess the condition of the cement flashing which supports the chimney pots and some repair/repointing may be needed.

Photo - 4 Rear elevation stack

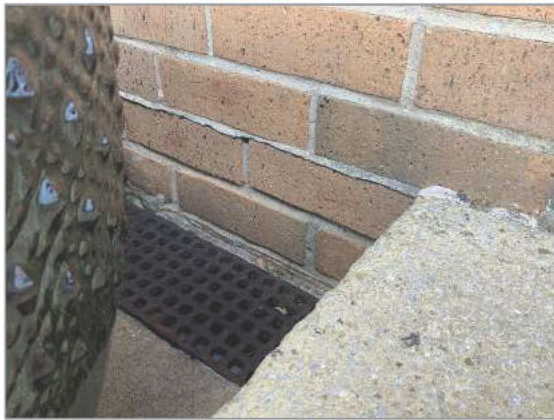
Rear elevation DPC is level with internal finish floor level. DPC can be seen to follow line of corner steps to rear. It also steps upwards to follow line of side pathway. It should be verified by vendor how side gable elevation is tanked to prevent moisture ingress as paving and steps are higher than internal finish floor level to rear living room adjacent.

Photo - 23 Rear elevation damp proof course is level with internal finish floor level

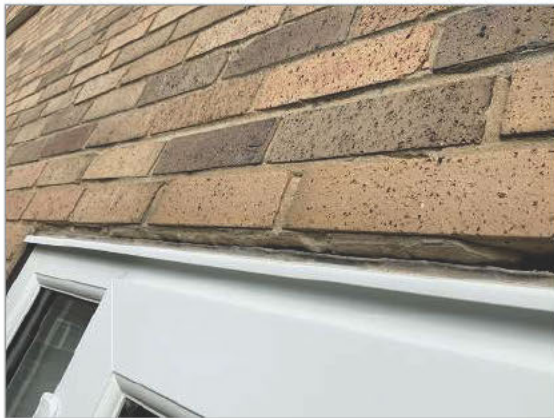
Pointing to rear French doors and steel lintel has fallen out. This should be replaced. It does however confirm presence of steel galvanised lintel above opening. It is presumed other lintels are

of same construction throughout property.

Photo - 25 Pointing to rear French doors and steel lintel

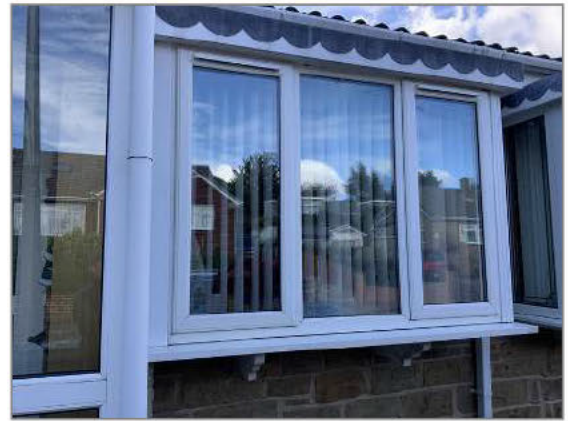
Photo - 28 Kitchen bow window is supported by timber noggins set into masonry behind and below

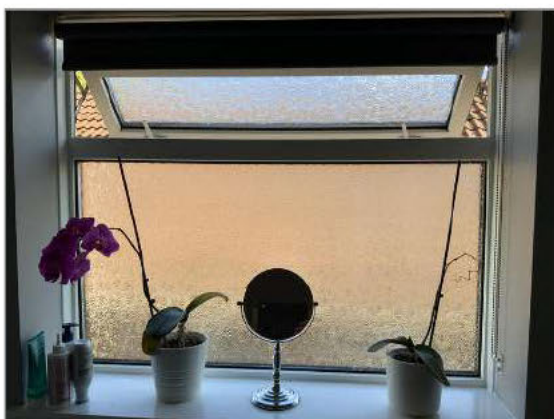
Photo - 35 Bathroom window hinge to front has become sprained preventing window closing fully at top.

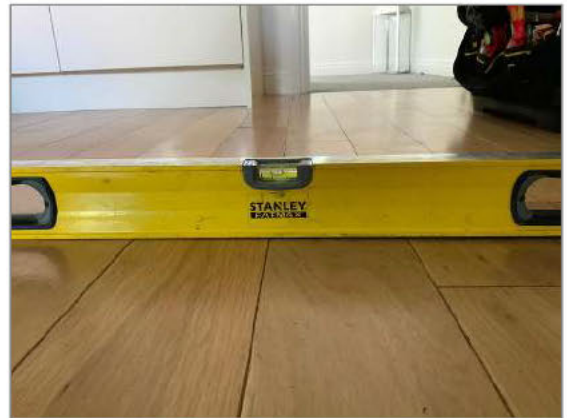
Photo - 89 Kitchen floor drops to left and rigging center

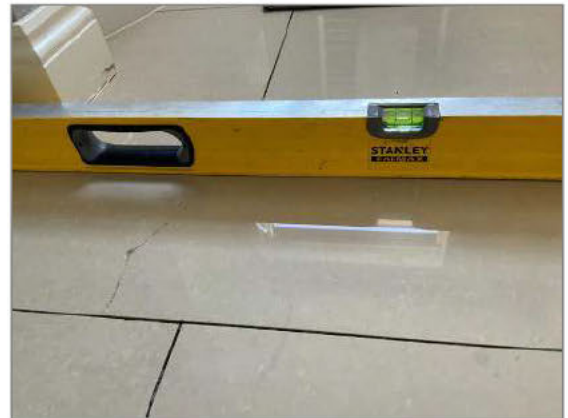
Photo - 95 Bathroom floor drops to rear by approximately 3mm/m

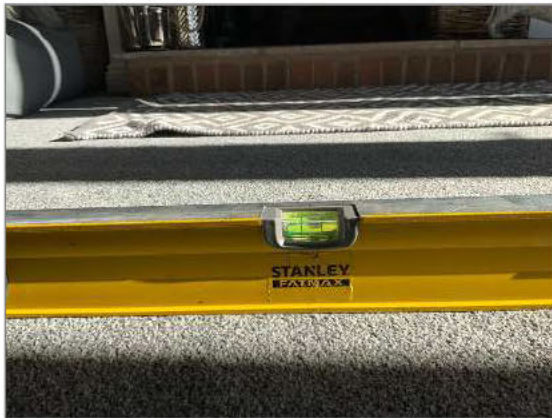
Living room floor drops to front by approximately 6mm/m, this gradient may be influenced by wear of carpet.

Photo - 98 Living room floor

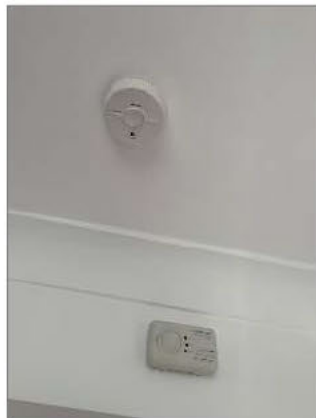
Photo - 158 Living room has a carbon monoxide detector and battery smoke alarm
