LEVEL 3

Your survey report

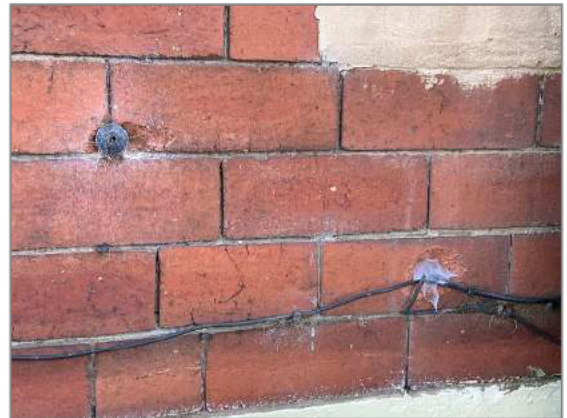
Photo - 16 Minor damage to bricks

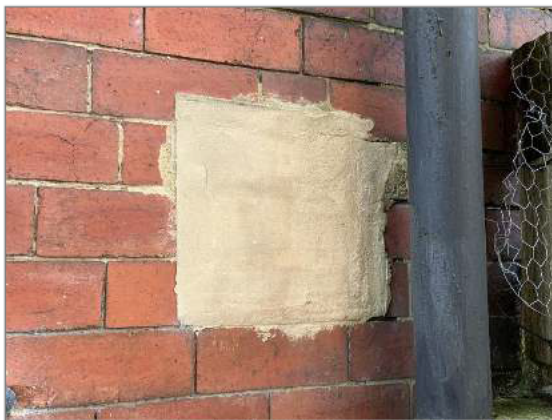
Photo - 17 Rough patch repair

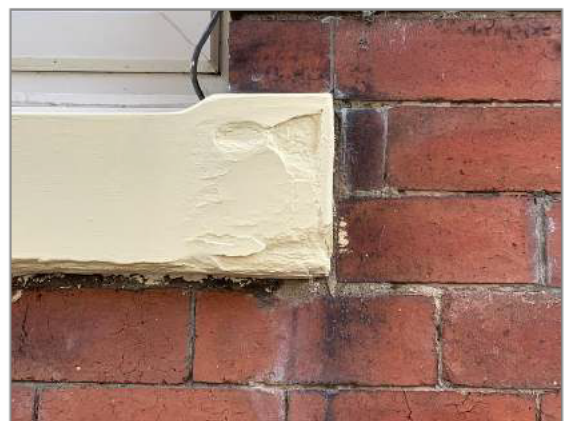
Photo - 20 Spalled stone to lintels and sills

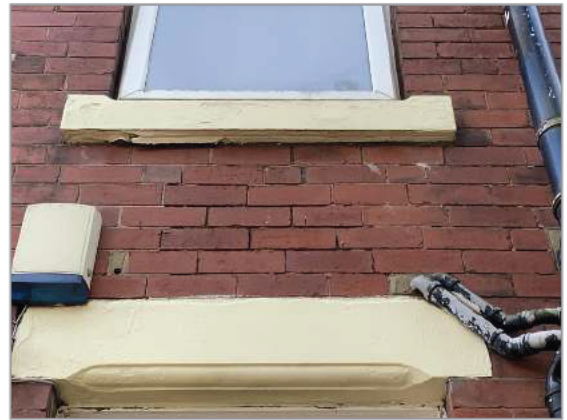
Photo - 22 Open mortar joints

- There is a large tree in the front yard, close to the house. We recommend that this tree should be removed.
- The mortar joints to the elevations and chimney stack are eroded and should be repointed soon.

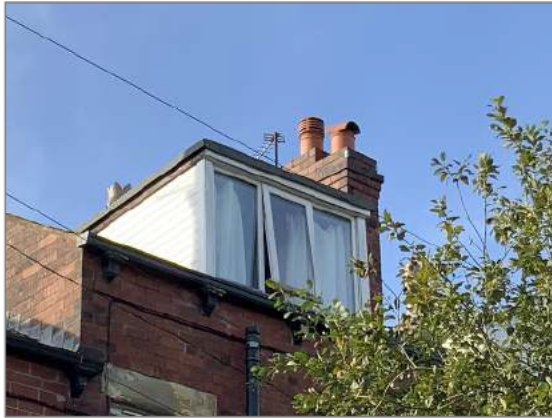
Photo - 25 Staining to dormer windows

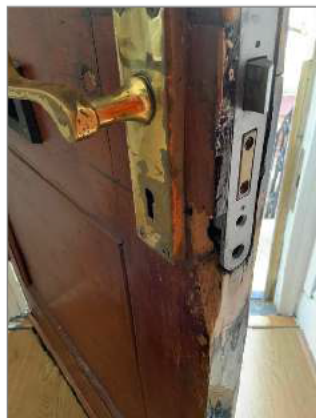
- There is impact damage to the interior of the front door around the lock mechanism.
- There is unevenness to the living room and fine cracks to the second floor bedroom ceiling, indicating that the plaster is beginning to detach from the wooden laths.

Photo - 31 Impact damage to front door

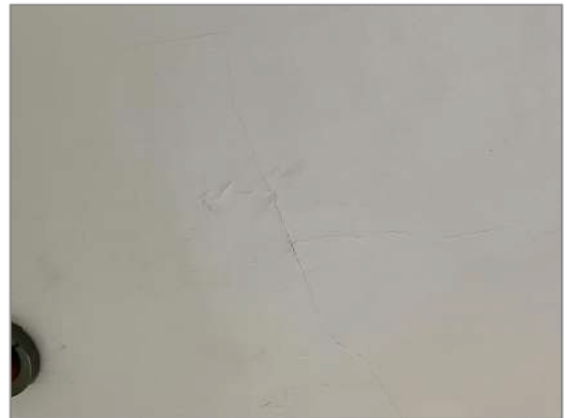
Photo - 44 Fine cracks to second floor bedroom ceiling

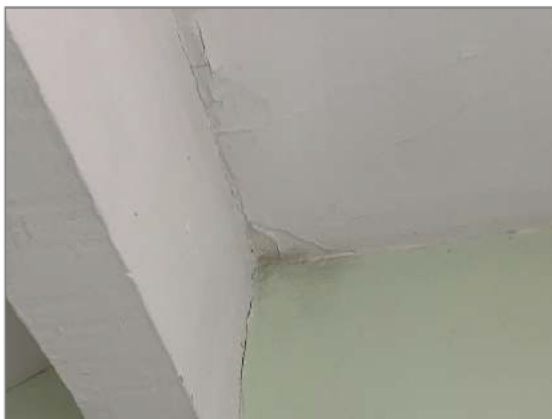
Photo - 45 Possible damp staining above second floor stairs

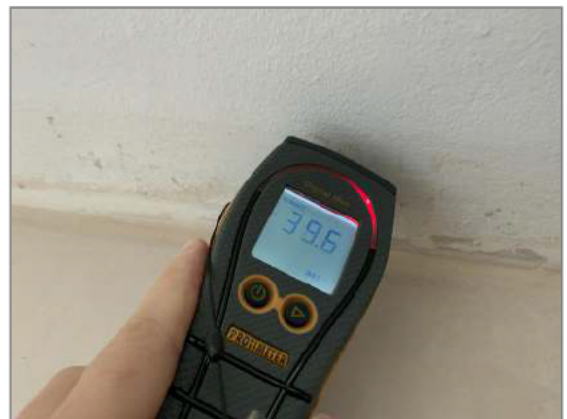
- Damp was found to the second floor bedroom ceiling below the chimney stack, to the left of the lower ground floor door, and to the first floor bedroom wall on the date of this report.

Photo - 46 Damp found to ceiling above second floor chimney breast

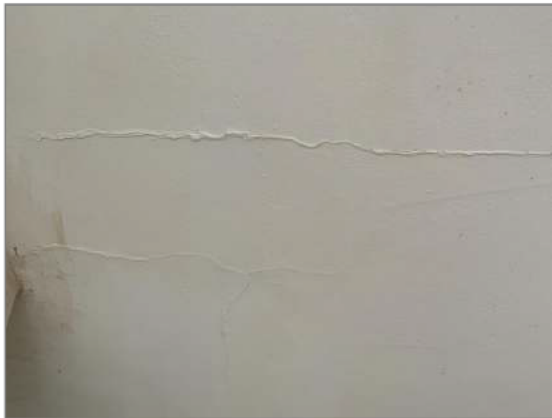
Photo - 47 Cracks to second floor bedroom ceiling

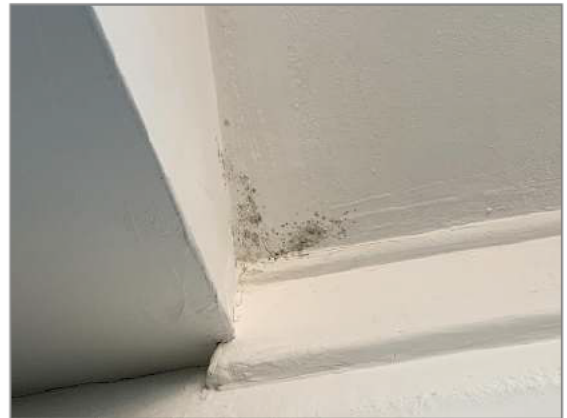
Photo - 48 Black mould growth to dormer ceiling

There is black mould growth around the dormer window reveal indicating a build up of condensation. Please refer to section E2 Ceilings for information regarding managing condensation.

- While cooking, bathing or washing use an extractor fan and/or open a window, and keep the door closed. Keep the extractor fan on and/or the window open for about 20 minutes after you have finished (with the door closed).
- When condensation appears, wipe it away.
- Leave trickle vents (slotted vents in the window frames) open when rooms are occupied – even in the winter when your heating is on. These vents provide constant ventilation which removes water vapour.

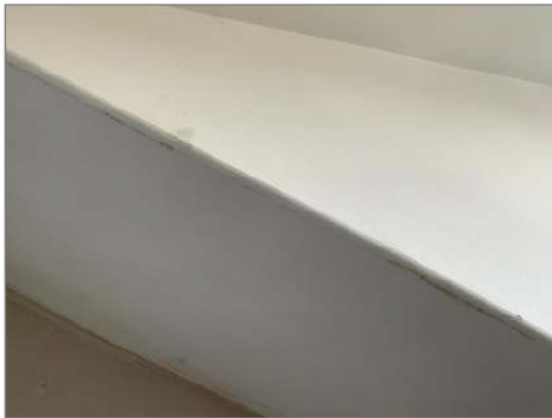
Photo - 49 Staining may indicate leak between main roof and dormer

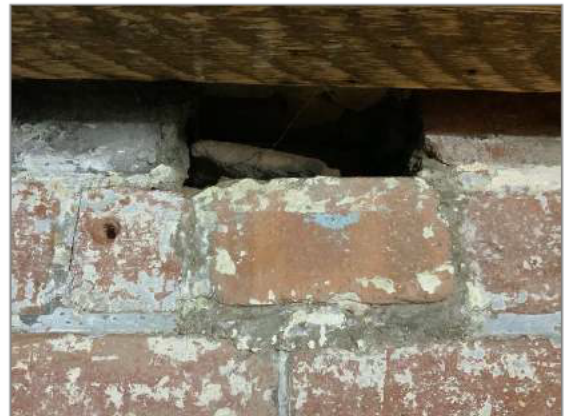
Photo - 53 Missing brick from kitchen wall

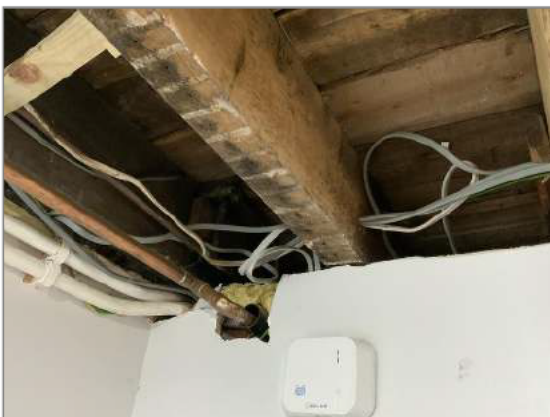
Photo - 54 Poor finish to top of kitchen walls

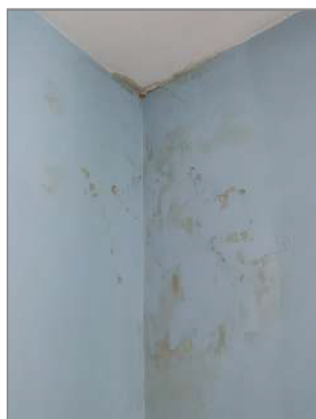
Photo - 60 Significant damp staining to first floor bedroom wall

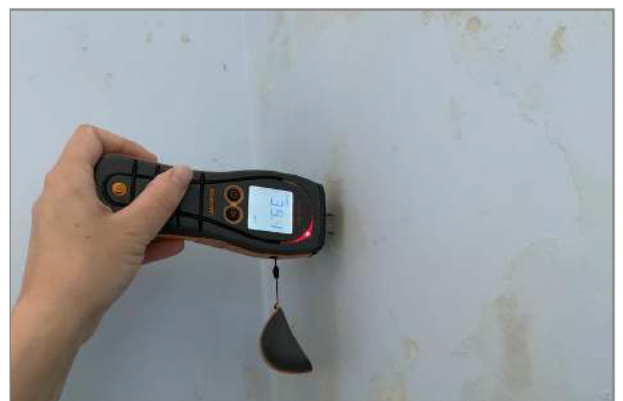
Photo - 61 Damp found to staining to first floor bedroom wall

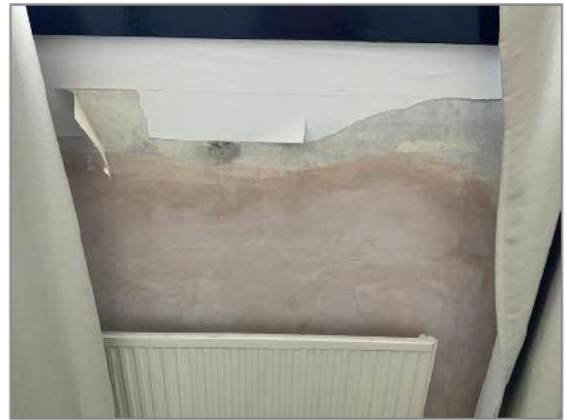
Photo - 63 Peeling wallpaper and patch repairs to plaster to second floor bedroom wall

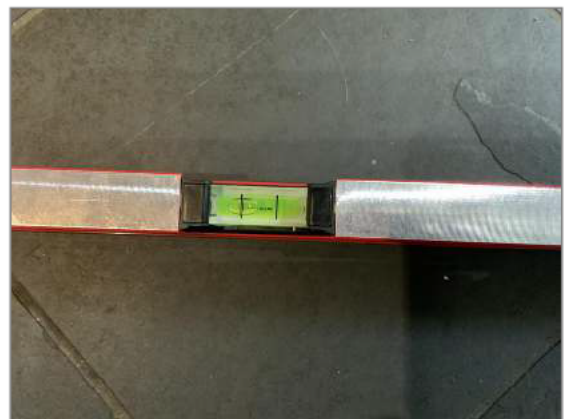
- The lower ground floor slopes significantly front to back and is uneven left to right.
- The laminate to the living room is loose and there are gaps between some of the planks. There is a stain to the second floor bedroom carpet. You may wish to budget for replacing these floor coverings.
- We recommend that you obtain a damp and timber report.
- We recommend that you obtain a CCTV survey of the drains.
- We recommend that you obtain a refurbishment & asbestos survey prior to any invasive works.
- Gas and electric installations should be serviced by competent contractors.

Photo - 69 Lower ground floor slopes significantly

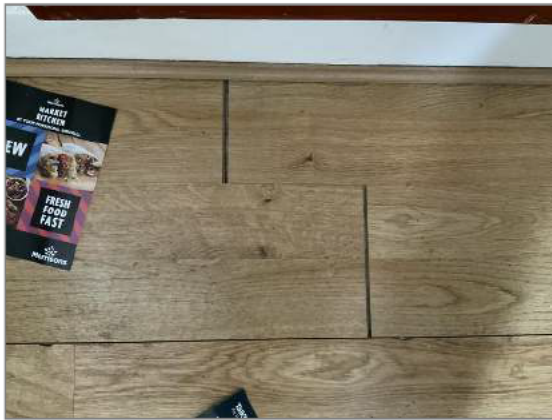
The floor coverings are a combination of laminate, carpet, tile and exposed floorboards. The laminate to the living room is loose and there are gaps between some of the planks. There is a stain to the second floor bedroom carpet. You may wish to budget for replacing these floor coverings and you may also wish to budget for fitting a carpet to the first floor bedroom.

Photo - 76 Loose laminate to living room floor

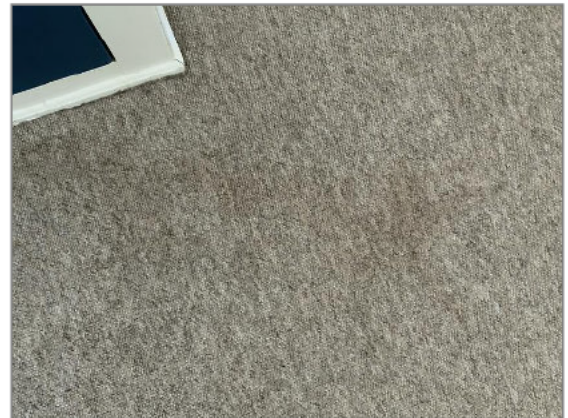
Photo - 83 Stain to second floor bedroom carpet

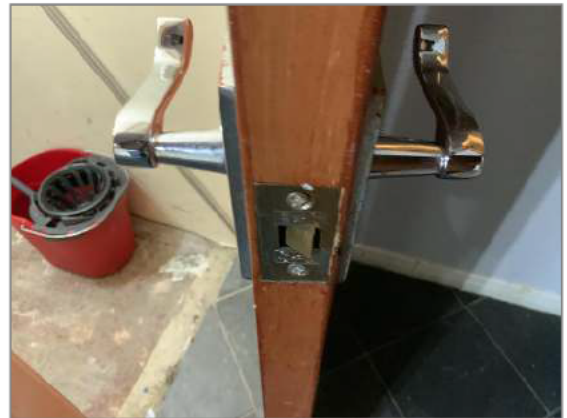
Photo - 98 Broken latch mechanism to lower ground floor cupboard door

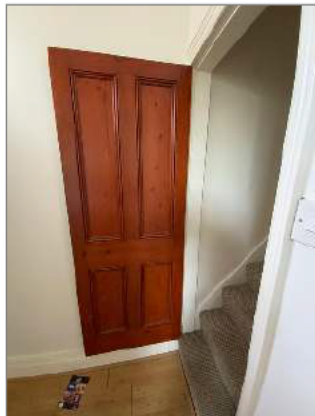
Photo - 99 No fire doors fitted

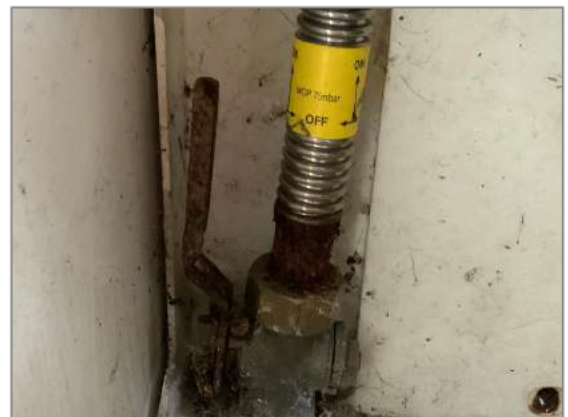
Photo - 108 Corroded pipe

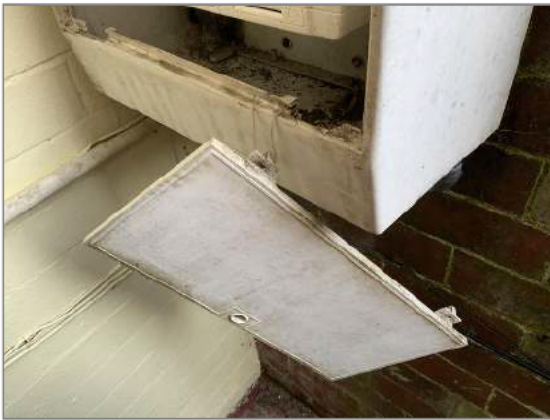
Photo - 109 Broken meter box door

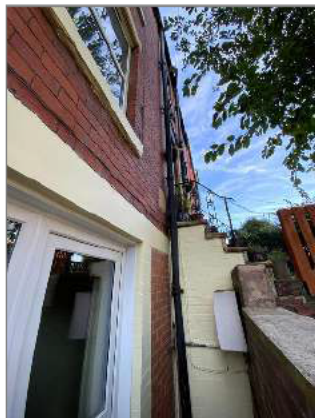
- The paint to the cast iron soil and vent pipe is peeling and there is corrosion to the pipe. A number of the bracket fixings have completely failed. The pipe should be replaced.

Photo - 112 Cast iron soil and vent pipe

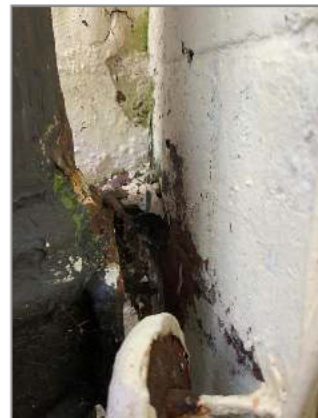
Photo - 113 Failed brackets to soil and vent pipe

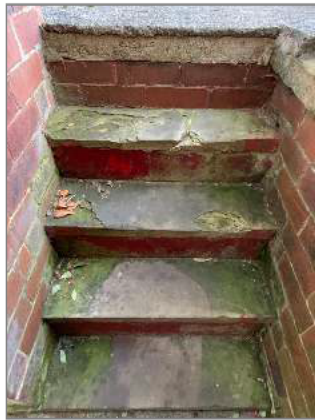
The stone treads to the garden steps are cracked in places and should be repaired using lime mortar or replaced. The left handrail to the front door steps is loose at the base where the stone has cracked and should be re-fixed.

Photo - 115 Cracked stone treads to steps to lower ground floor

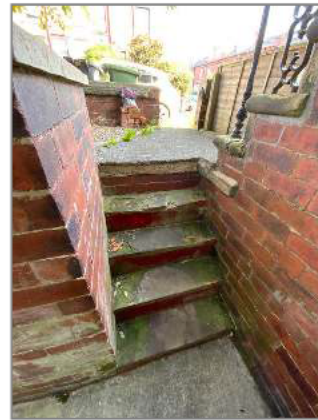
Photo - 116 No handrail to lower ground floor steps

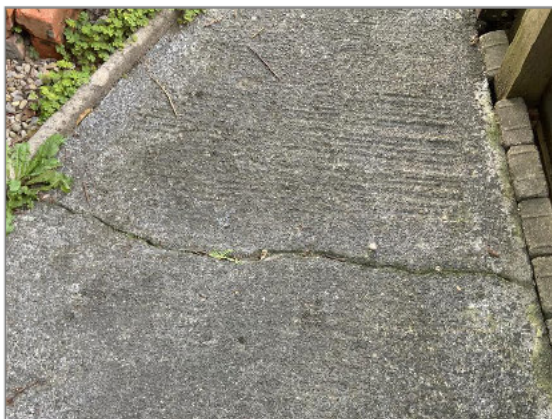
Photo - 119 Crack to concrete path

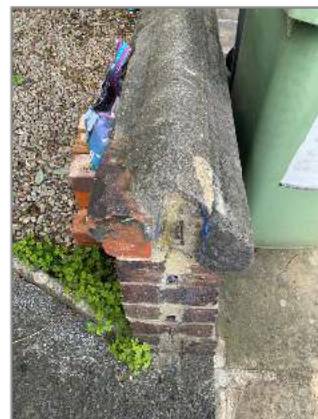
Photo - 120 Damage and movement to front boundary wall

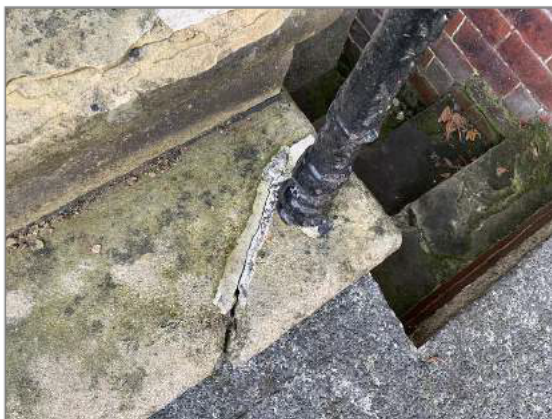
Photo - 125 Cracked stone step

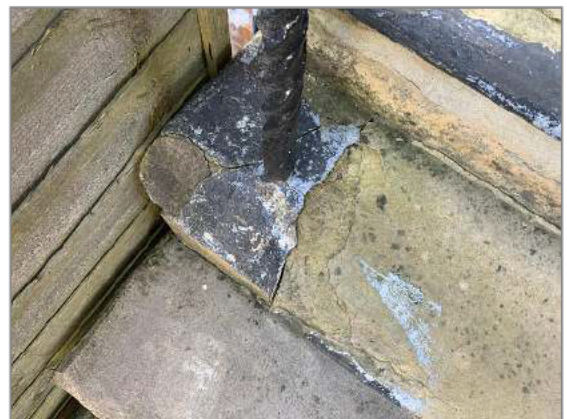
Photo - 126 Cracked stone step and handrail loose
