LEVEL 3

Your survey report

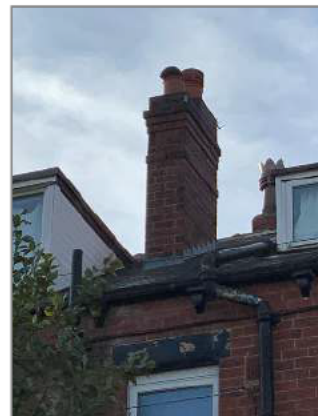
Chimneys are naturally exposed to the elements and adversely affected by rain, snow and frost. They are also exposed to heating and cooling. The masonry and mortar is particularly susceptible to frost damage which often results in erosion and 'spalling' of the masonry. Porous masonry absorbs moisture which freezes and expands in cold weather and forces off the exterior face of the brick/stonework. This is known as spalling.

Photo - 3 Chimney stack

Chimney repairs tend to be relatively expensive as, for safety purposes and to avoid damaging the roof coverings, contractors will have to use appropriate access equipment (for example scaffolding, hydraulic platforms, etc.).

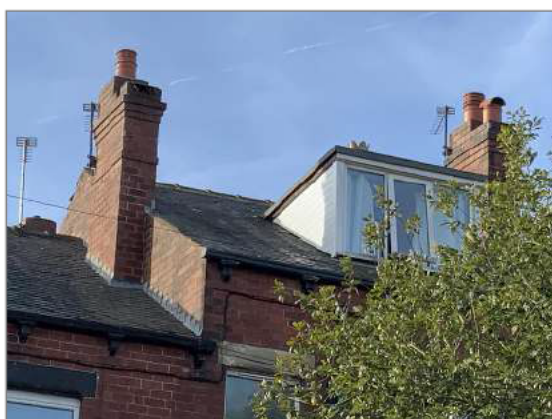
The roof is pitched and surmounted with slates, with clay ridge tiles. No significant sagging was noted to indicate any weakness of the roof structure. There are a number of slipped and cracked slates and tingle repairs. Tingles are thin strips of copper or lead attached to the tile battens and used to support loose slates. Any slipped or cracked slates should be replaced as soon as possible to prevent water penetration.

There is a flat roof to the dormer which appears to be surmounted with felt. It was not possible to inspect the flat roof covering from ground level and we cannot comment on its condition. We recommend inspection from suitable access equipment.

Photo - 6 Main roof covering and flat roof to dormer

You are recommended to budget for replacement of this roof covering in the near future. This should be carried out soon as slipped slates allow water ingress which can structurally weaken roof timbers and damage internal finishes. Additionally falling slates are heavy and may be a safety risk to passers by.

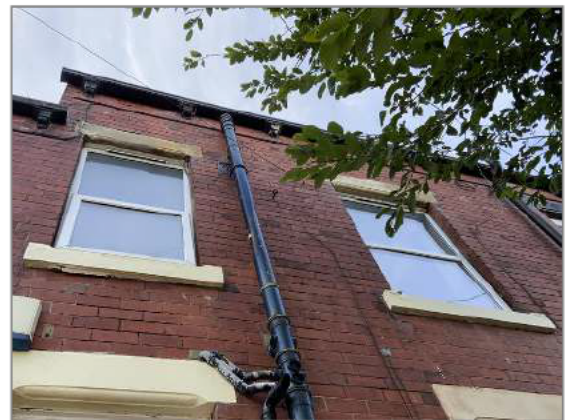
The gutter is of modern PVC and appears in satisfactory condition from ground level inspection. The gutters are shared with the adjoining property and there is no downpipe located to this property.

Photo - 10 Gutter

It was not raining at the time of inspection and I cannot confirm if the rainwater goods are performing adequately. As such, it would be prudent to observe the goods during a period of heavy rainfall, note defective sections (if any) and repair/replace accordingly.

Gutters can easily get blocked by leaves and debris and cause overflow resulting in damp walls. The stop ends are particularly vulnerable to leakage. I would recommend that gutters and joints are maintained on a cyclical basis. In addition, the downpipe should be checked, to ensure that there are no blockages and that water is free-flowing.

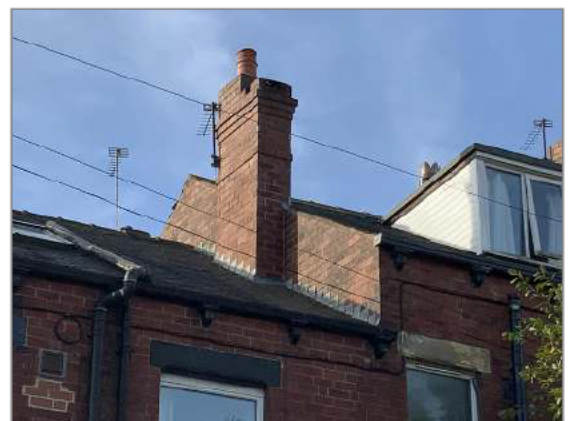
There is lead flashing to the side elevation at the junction with the adjoining property roof. This appears adequate from ground level inspection but due to the age of the lead small defects are likely and we recommend that you budget for replacing this in the future. The lead flashing is shared with the neighbouring property. The owner(s) of the neighbouring property may have a number of legal rights over this shared flashing. You should check with your legal advisor regarding your rights and responsibilities. If any repair or maintenance works are required to any shared elements, it is recommended that you supply notification to your neighbours with plenty of time to respond. In some situations, work may require detailing in writing or a party wall agreement.

Photo - 14 Side elevation

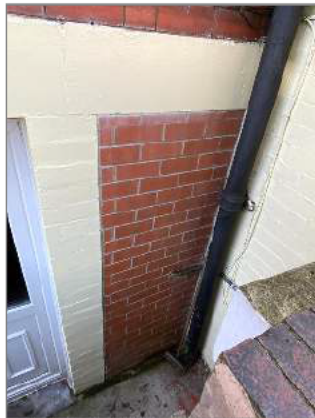
There is a bricked up door opening to the lower ground floor, a bricked up alteration to the side of the front door steps, and various patch repairs from minor alterations.

Photo - 15 Bricked up door opening to lower ground floor

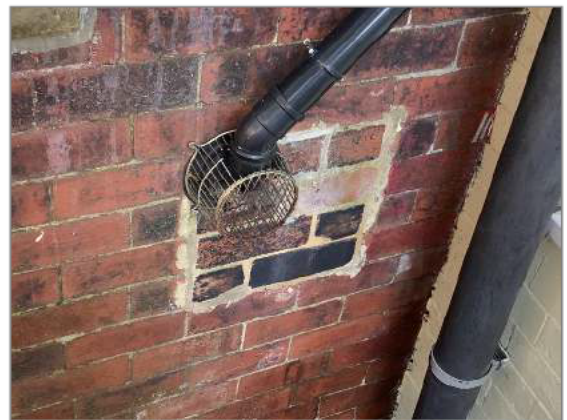
Photo - 18 Bricked up alteration

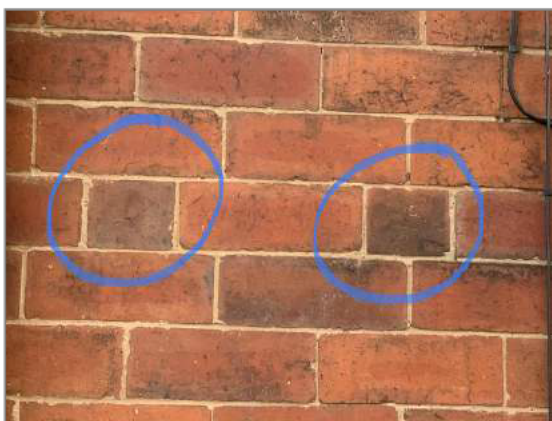
The walls are of traditional solid brick construction and were straight and plumb when checked with a spirit level. The presence of header bricks (bricks laid perpendicular to the wall to tie together the two leaves of masonry), along width the width of the walls, indicate solid wall construction. Solid walls have to be carefully maintained to prevent damp penetration. Penetrating dampness can usually be reduced to acceptable levels by ensuring that the external fabric of the building through the outer walls or roof coverings or defective brickwork or joints. The mortar joints to the elevations are eroded and should be repointed soon to prevent water penetration.

Photo - 19 Header bricks indicate solid wall construction

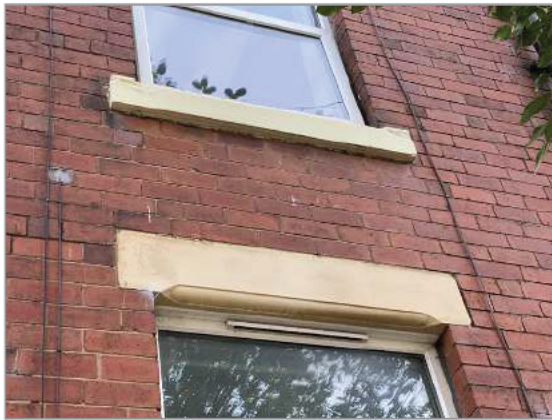
There are stone lintels above the window and door openings to support the loading above, and stone sills below the window openings. These are generally adequate however there has been some past spalling of the stone, although this is superficial and does not appear to have affected strength. The lower ground floor wall and the stone lintels and sills are finished with paint which is peeling in places. A film forming non-breathable masonry paint has been used which does not

allow moisture to evaporate from the stone. Moisture travels to the edges of the painted area which can cause spalling and deterioration of the stone at this point. Removal of the paint is however not recommended as this is likely to cause further damage. Keeping the paint in good condition and repairing any cracks as they appear can prevent moisture ingress and minimise deterioration.

Photo - 21 Stone lintels and sills

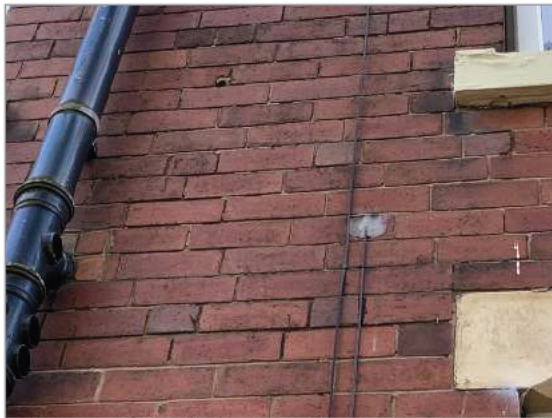
Photo - 23 Open mortar joints

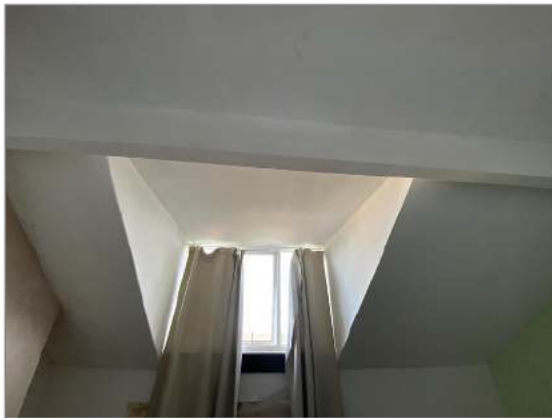
Damp meter readings were taken of the partially exposed timber purlin and no damp was found to accessible parts of the purlin on the day of our inspection, however paint may conceal defects. I saw nothing to indicate any weakness of the roof structure, however there may be concealed defects and you should budget for possible timber repair or replacement as well as upgrading to insulation.

Photo - 34 Roof structure concealed by internal finishes

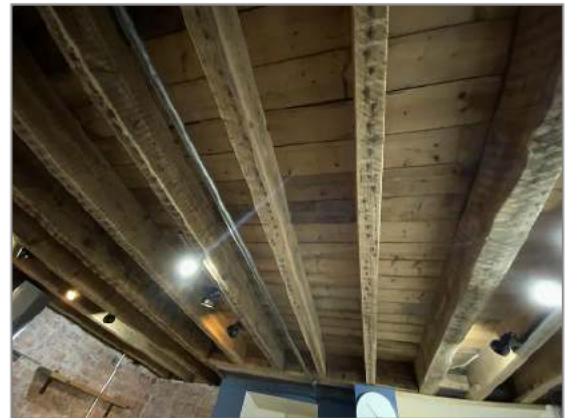
Photo - 36 Exposed joists to kitchen ceiling

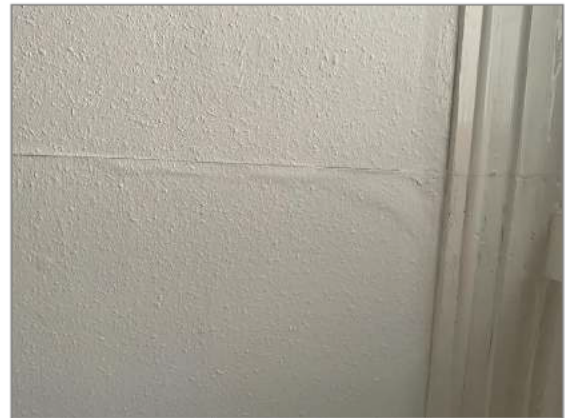
Photo - 38 Peeling wallpaper to living room ceiling

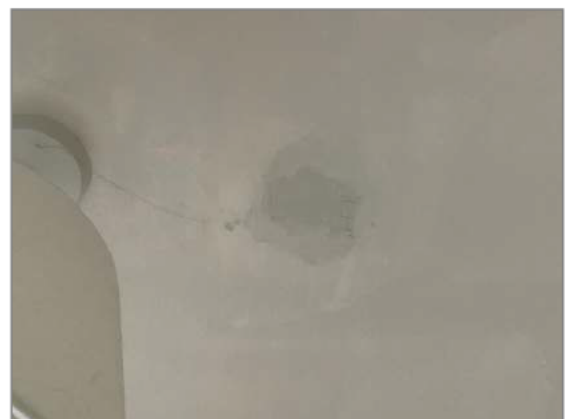
Photo - 40 Patch repair to landing ceiling

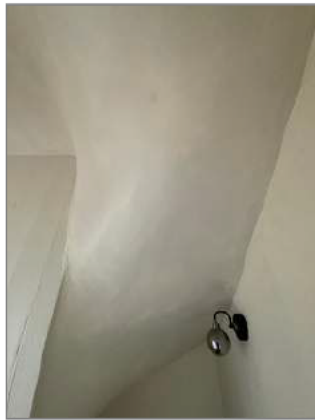
Lath and plaster ceilings are difficult to repair as large areas can be dislodged by the repair work itself. In some cases, it may be more economical to replace the whole ceiling.

Photo - 41 Lath and plaster ceiling to underside of second floor stairs

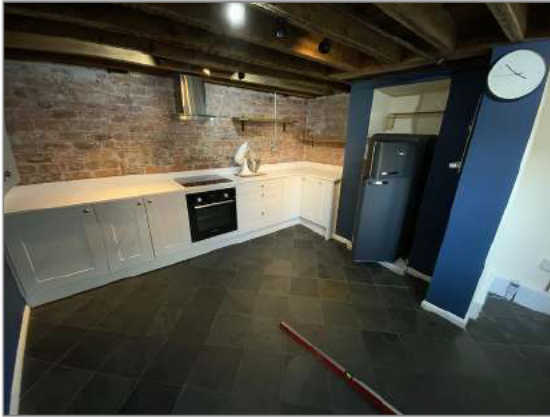
The walls are finished with a combination of exposed brick, paint, wallpaper, painted timber panelling and tiles. The timber panelling is a surface fire spread risk and should be coated with fire retardant paint. There are two bricks missing from the kitchen wall which looks poor and you may wish to source matching bricks to fill the gaps. There is a poor finish to the timber infills either side of the living room chimney breast and you may wish to budget for removing these and making good the surrounding walls. The wallpaper to the second floor bedroom has been partially removed which looks poor and the rest of the wallpaper should be removed from that wall. If you plan to remove the wallpaper, we strongly recommend inspecting for cracks and damp patches as wallpaper can cover these elements. Removal of the wallpaper is likely to damage the plaster beneath and you should budget for re-plastering if this is carried out.

Photo - 50 Tiles, paint and exposed brickwork to kitchen walls

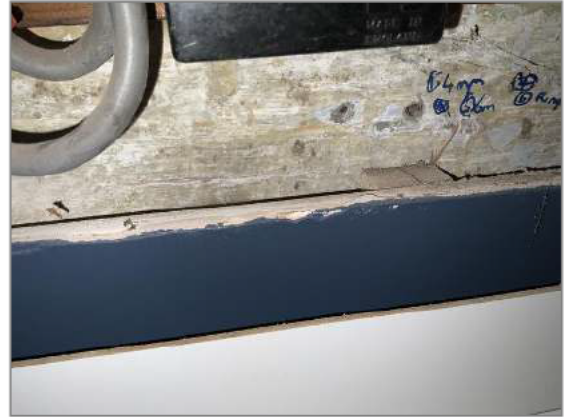
Photo - 51 No damp proofing visible around edges of dry lining to kitchen

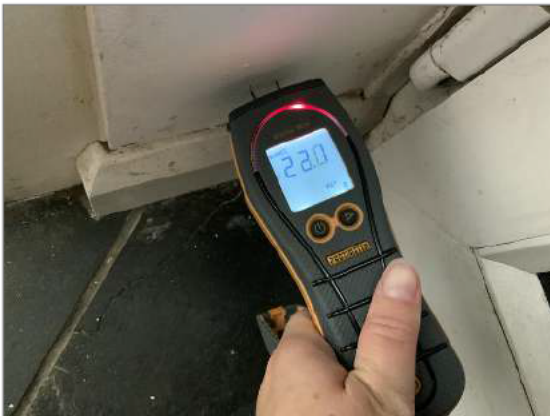
Defective gutters and downpipes and splash back from missing and broken rainwater goods can allow dampness to occur. In any event the cause of the penetrating dampness should be investigated and all necessary remedial works carried out.

Photo - 52 Damp to left of lower ground floor door

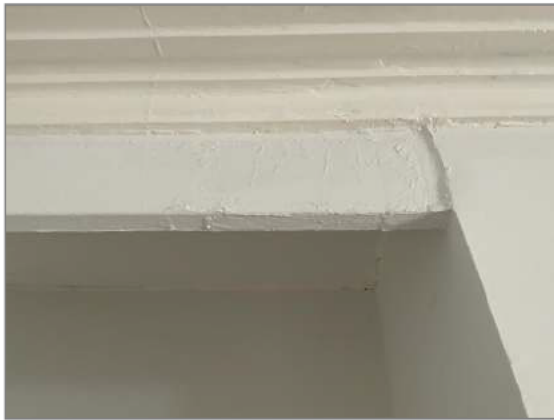
Photo - 56 Poor finish to timber infills either side of living room chimney breast

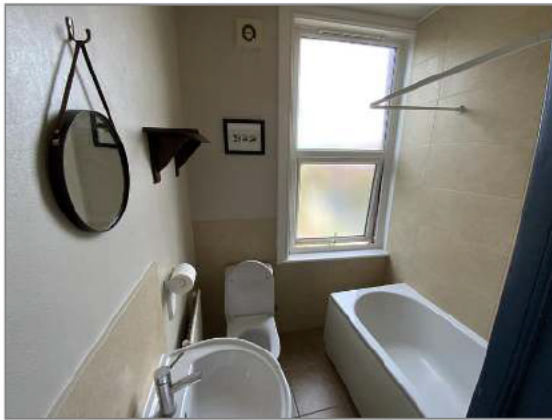
Photo - 62 Paint and tiles to bathroom walls

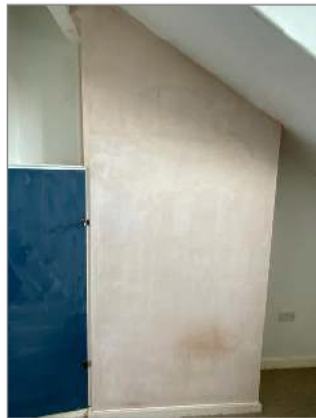
Photo - 64 Recent re-plastering to second floor bedroom chimney breast

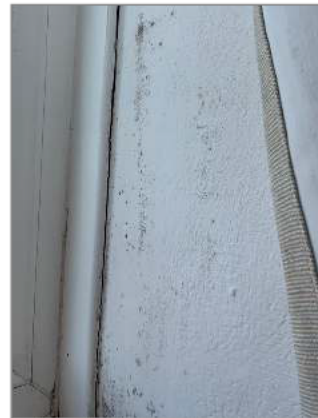
Photo - 65 Black mould growth around second floor window opening

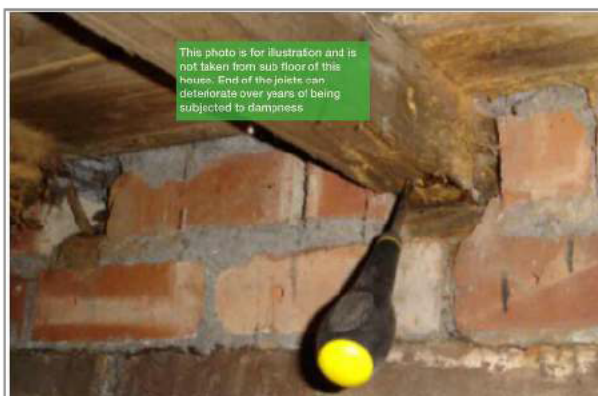
With suspended timber the end of the joists are vulnerable to timber decay; cross ventilation is essential to keep the joists dry and free from decay.

Photo - 86 Not of this property - show to highlight the effects of damp/rot to subfloor timbers

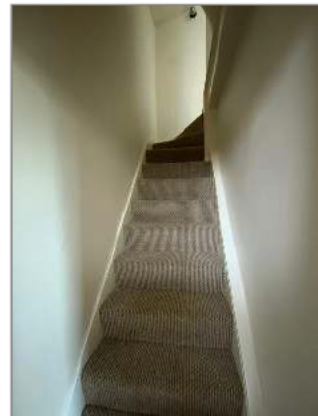
Photo - 100 No handrail to first floor stairs

The main stairs rise at a pitch of approximately 43 degrees, which is steeper than the maximum allowed by current Building Regulations (42 degrees). While it is not reasonable to replace the stairs, it is important to ensure the handrail remains fitted.

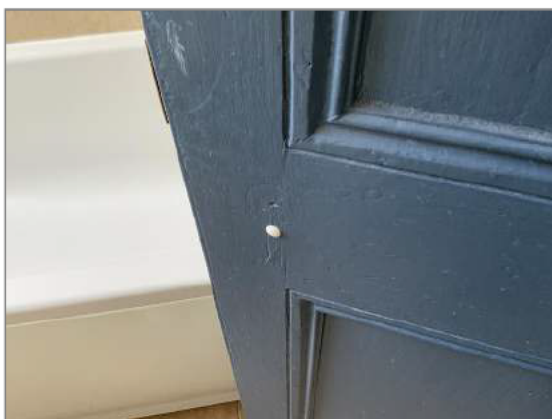
Photo - 101 No external handle to bathroom door

The latch mechanism to the lower ground floor cupboard door is broken and should be replaced. There is no external handle fitted to the bathroom door and we recommend that one should be fitted.

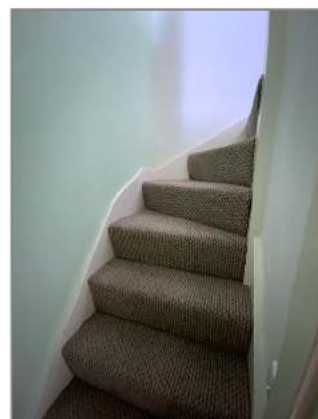
Photo - 102 No handrail to second floor stairs

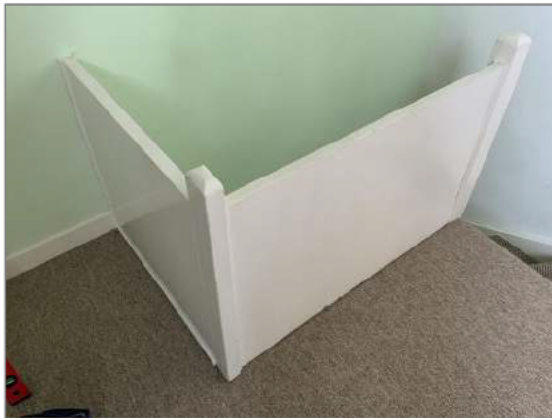
The guarding to the second floor landing does not comply with current Building Regulations as it is too low at approximately 700mm. This is a safety risk and the guarding should be replaced.

Photo - 103 Second floor landing guarding too low at approximately 700mm

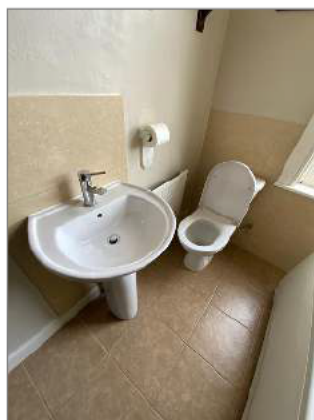
Photo - 104 Bathroom

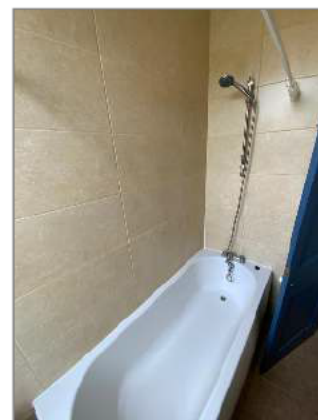
Photo - 105 Bathroom

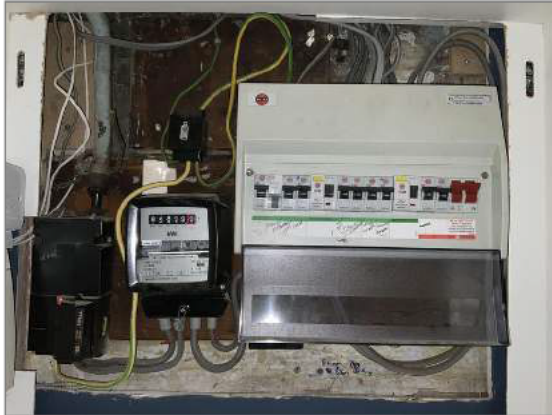
No evidence of recent testing was noted.

In the absence of a current test certificate, we must designate a level three risk. If certification is available, please ask your legal advisor to check the validity of this evidence. Electrical installations to be checked and certified by an NICEIC qualified engineer prior to purchase, unless evidence of recent testing is provided and verified.

Photo - 106 Electric meter and consumer unit

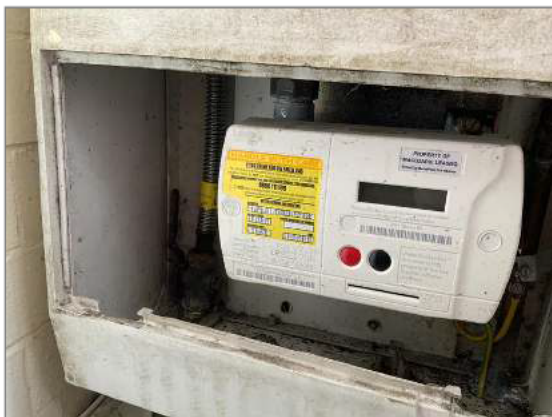
The gas meter pipework is damp and beginning to corrode. You should ask an appropriately qualified person to inspect the gas installation system now.

No evidence of recent testing was noted.

Photo - 107 Gas meter

In the absence of a current test certificate, we must designate a level three risk. If certification is available, please ask your legal advisor to check the validity of this evidence. All gas installations to be checked and certified by a Gas Safe engineer prior to purchase, unless evidence of recent testing is provided and verified.

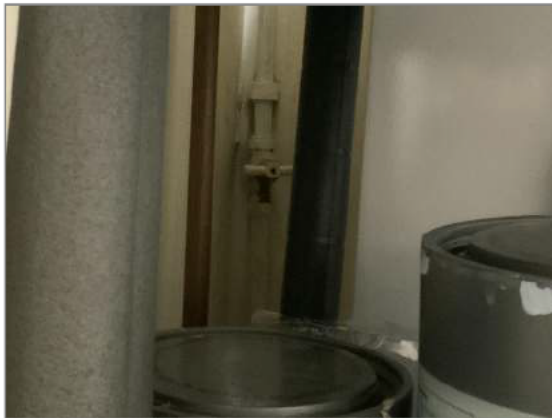
The distribution plumbing where visible comprises of copper pipe work. No significant leakage was noted on the surface although most of the pipe work is concealed in ducts and floors.

In properties with older plumbing systems, particularly where copper pipes are hidden, then leaks can occur which are not readily apparent. Some repairs and replacements of the pipe work should be anticipated.

Photo - 110 Internal stop tap

We recommend that you instruct a competent contractor to provide a quotation to carry out repairs and any necessary associated work.

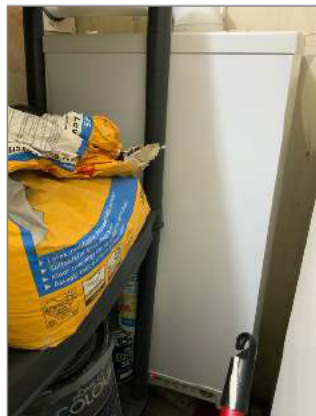
Our limited inspection of the system revealed no evidence to suggest any serious defects.

No evidence of recent testing was noted.

Photo - 111 Boiler

In the absence of a current test certificate, we must designate a level three risk. If certification is available, please ask your legal advisor to check the validity of this evidence. All gas installations to be checked and certified by a Gas Safe engineer prior to purchase, unless evidence of recent testing is provided and verified.

Please ensure you have a carbon monoxide alarm near all gas outlets.

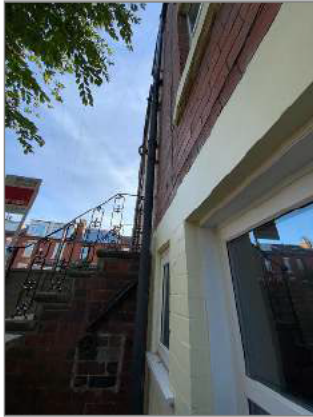
The property is connected to mains drainage. There are two soil and vent pipes to the property; one of PVC and one of painted cast iron. The paint to the cast iron pipe is peeling in a number of places and there is some corrosion to the pipe. A number of the bracket fixings have completely failed which may leave the pipe potentially unstable. Cast iron can crack and leak without warning, and falling cast-iron is heavy and may be a safety risk. The soil and vent pipe should be replaced soon. A terminal guard should be fitted to the top of the pipe to prevent blockage by birds.

Photo - 114 PVC soil and vent pipe

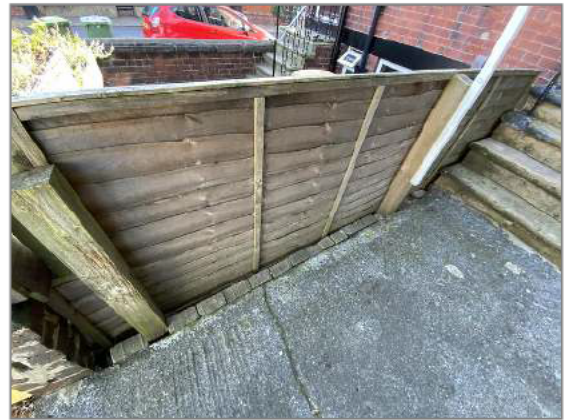
Photo - 122 Timber fencing to side boundaries
