LEVEL 2

Your survey and valuation report

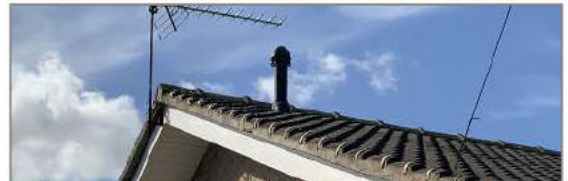
Photo - 7 Verge pointing is reasonably secure, mortar has shrunk slightly as it dried out

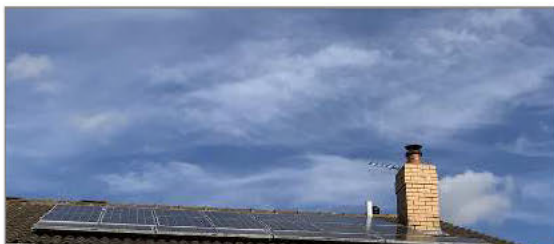
Photo - 10 Rear elevation

Rear elevation of roof has solar panels fitted. It should be inspected below or around panels to ensure there are no broken tiles or damage to roof covering, as it is expensive to have panels removed in order to repair roof. You should ensure roof covering life expectancy is greater than remaining life of solar panels.

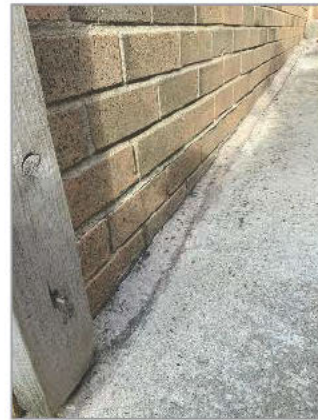
Rear elevation DPC is level with internal finish floor level. DPC can be seen to follow line of corner steps to rear. It also steps upwards to follow line of side pathway. It should be verified by vendor how side gable elevation is tanked to prevent moisture ingress as paving and steps are higher than internal finish floor level to rear living room adjacent.

Photo - 23 Rear elevation damp proof course is level with internal finish floor level

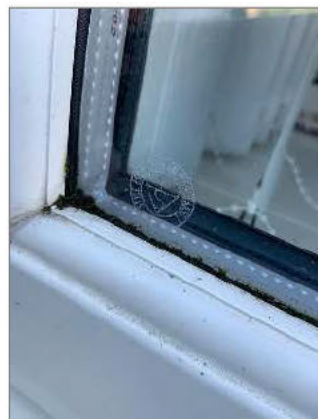
Photo - 29 Etched toughened

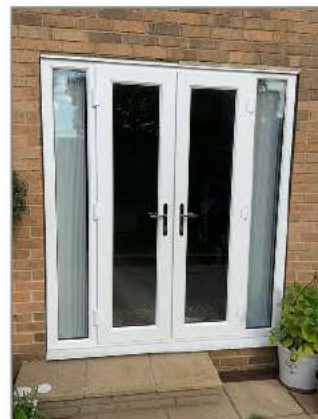
Photo - 40 Rear door to conservatory has a secure by design handle protecting cylinder

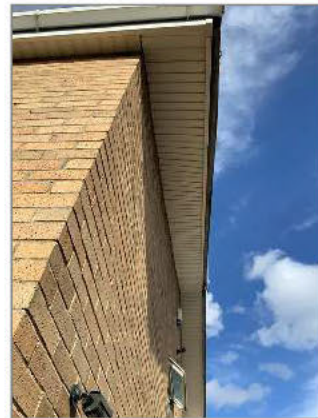
Photo - 56 Some ventilation is provided to eaves at soffits

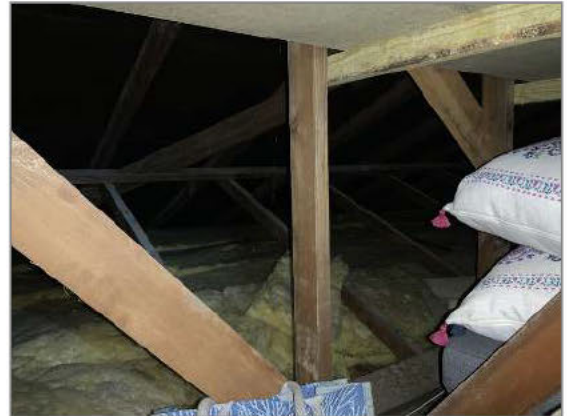
There is generally adequate insulation to front and rear eaves. Central portion of roof space has been boarded to ceiling joists and insulation removed to eaves. Boarding should be raised on loft stilts and any storage kept light as ceiling joists are not designed to carry heavy loads. Access should be maintained to boiler on gable wall of roof space.

Photo - 65 Front eaves

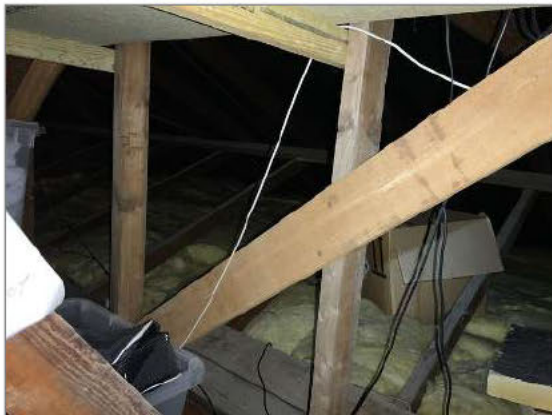
Photo - 66 Rear eaves

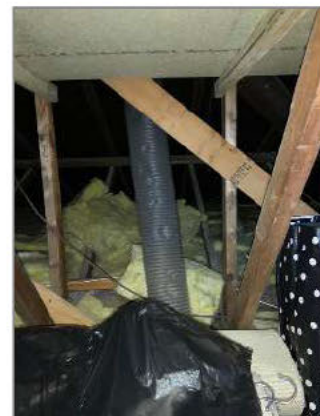
Photo - 69 Bathroom extraction ducting to roof is dented throughout its length

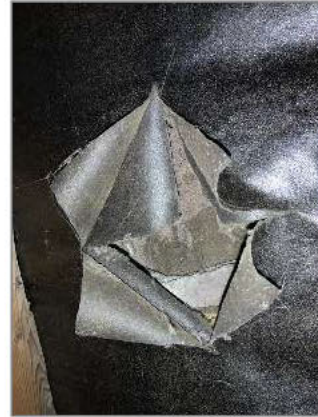
The black sheeting seen between the rafters is referred to as underfelt. Underfelt is used to catch water that falls behind tiling, which then runs down the underfelt and ideally into the guttering. Without this element in an area that features either a slipped or cracked tile, it will allow a hole through the roof covering, allowing water, debris and wild life to enter.

Photo - 71 Torn felt

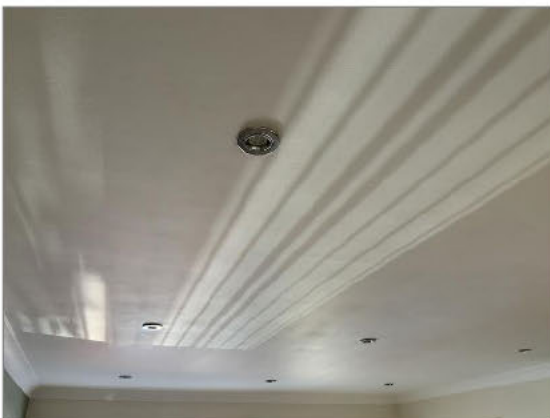
No cracks identified to ceilings or open board joints.

Photo - 72 Kitchen ceiling

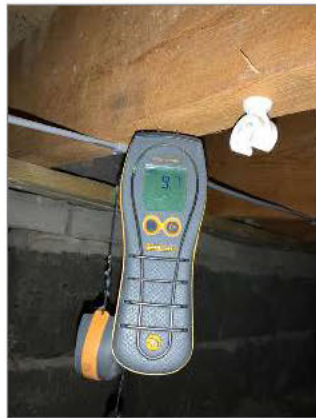
Subfloor of kitchen was inspected, no damp identified, subfloor ventilation is limited to front elevation. Additional ventilation is recommended to gable elevation if this is possible above level of steps.

Photo - 88 Damp meter reading under kitchen

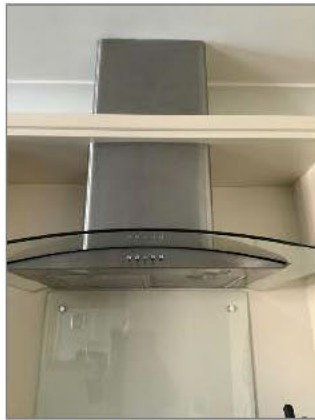
Photo - 106 Hob extraction is ducted through loft to roof space

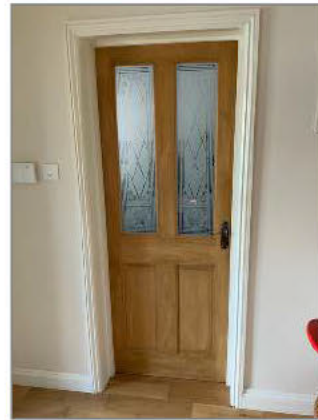
Photo - 110 Kitchen utility door

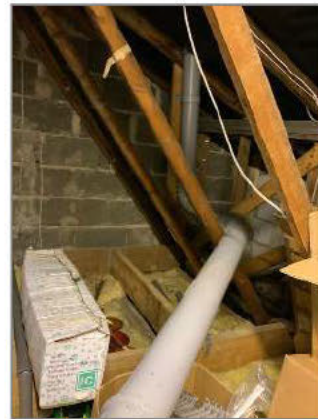
Soil stack is internal and has been relocated from its original exit in roof. This now has a very convoluted route to ventilation.

Photo - 138 Soil vent pipe has been relocated from its original exit in roof.

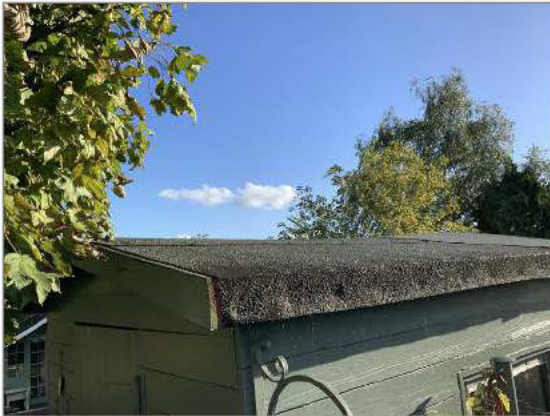
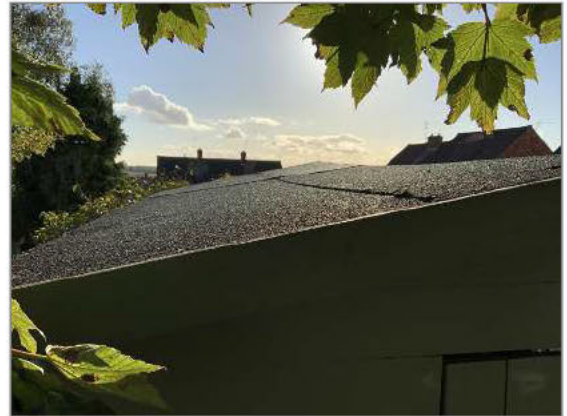
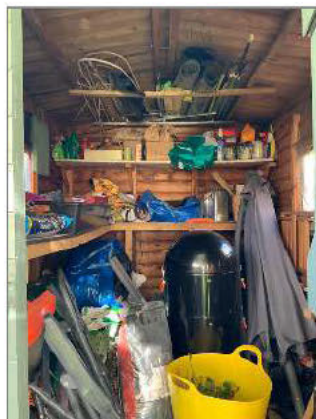
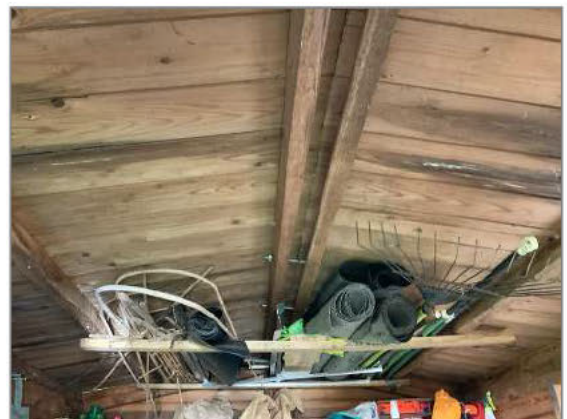
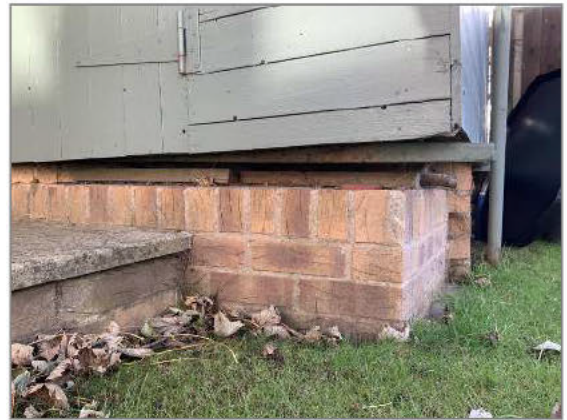
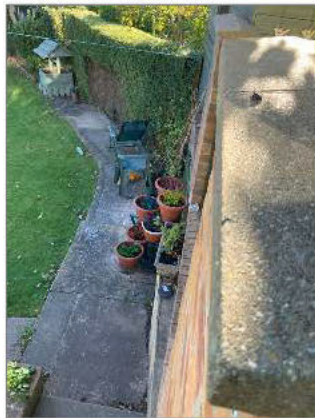
Shed is constructed on a brick foundation. Roof is in reasonable condition. Glazing is plastic. LHS window plastic is split to centre. This should be replaced for security purposes.

As previously described there are retaining walls to LHS and rear. These are of solid brick construction and appear adequately constructed and undamaged.

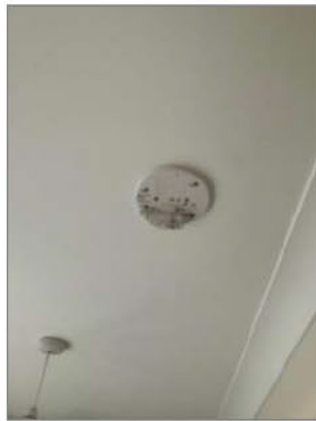
Photo - 156 Utility smoke alarm required a new battery

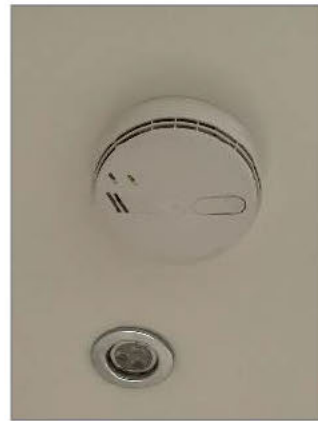
Photo - 157 Upper Landing smoke alarm
